CHARCOAL FUEL PRODUCTION FOR THE GLENDALE SMELTER

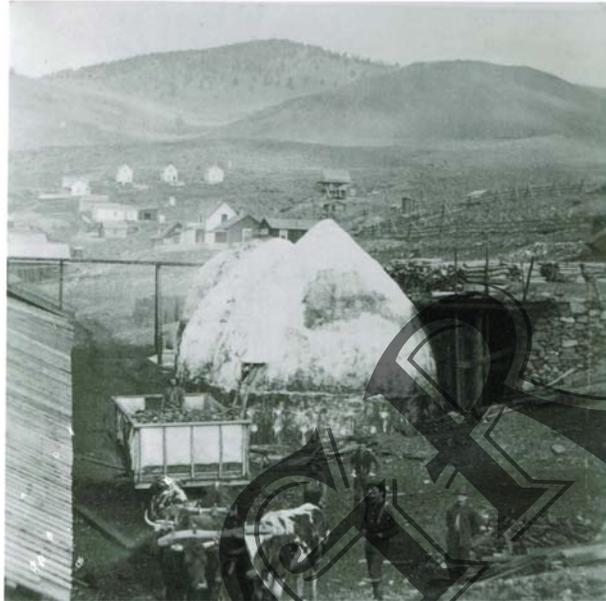
The first kilns built at Glendale.

Fuel was an important necessity for the smelting process and in 1876 four charcoal kilns were erected in a location directly across the road from the Dahler and Armstrong Smelter. Constructed of native stone, wood was transported to the site for the manufacture of the fuel.

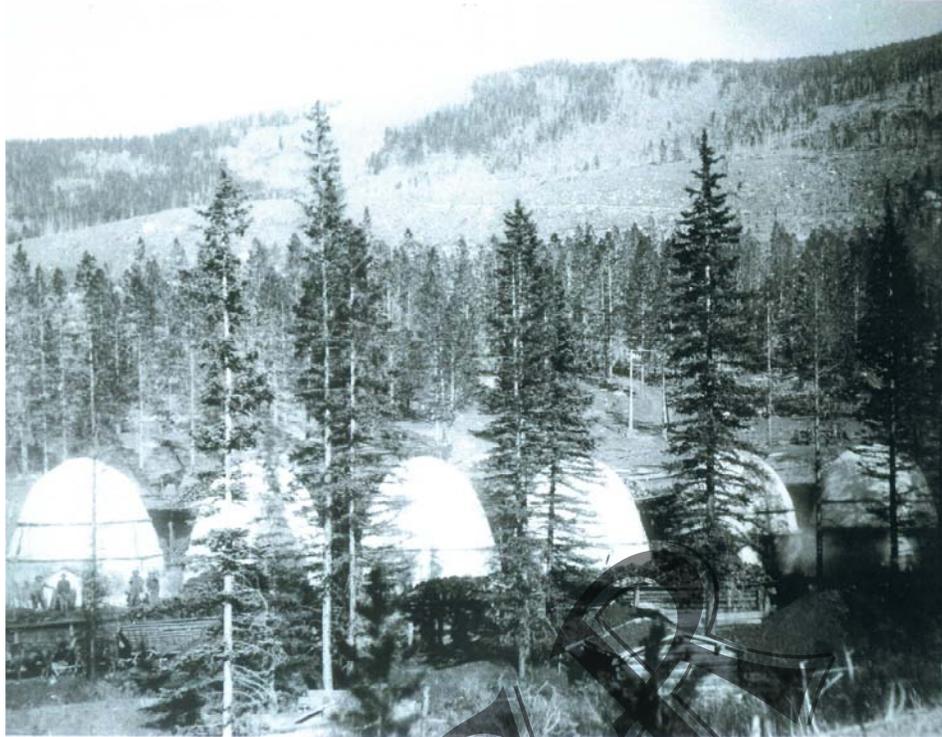
These kilns were located on the banks of Trapper Creek near Greenwood. Circa 1886.

In 1885, Sappington & Company, a partnership consisting of Henson Thomas Sappington and Henry Kappes, began to construct six kilns located on the banks of Trapper Creek near Greenwood, the site of the HCMC Concentrator. They were finished and began production by early November of that year. The following summer, the partners began construction of six more, which were located at the mouth of Sucker Gulch. On September 17, 1886, the Dillon Tribune reported that five had been completed and the final one half done.

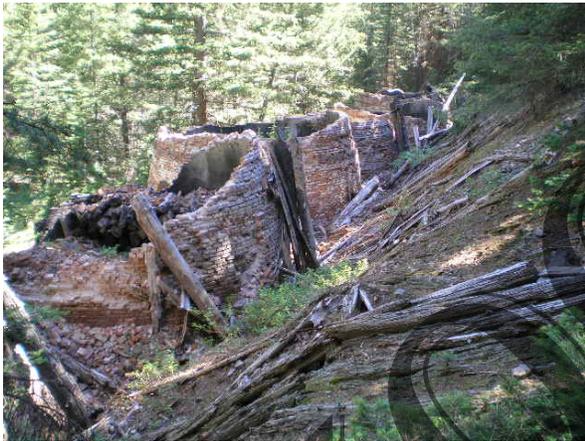
Sucker Gulch Kilns

These photos are present day images of the Sucker Gulch remains and the Greenwood kilns, respectively. A partial skeleton of the access scaffolding still is present.

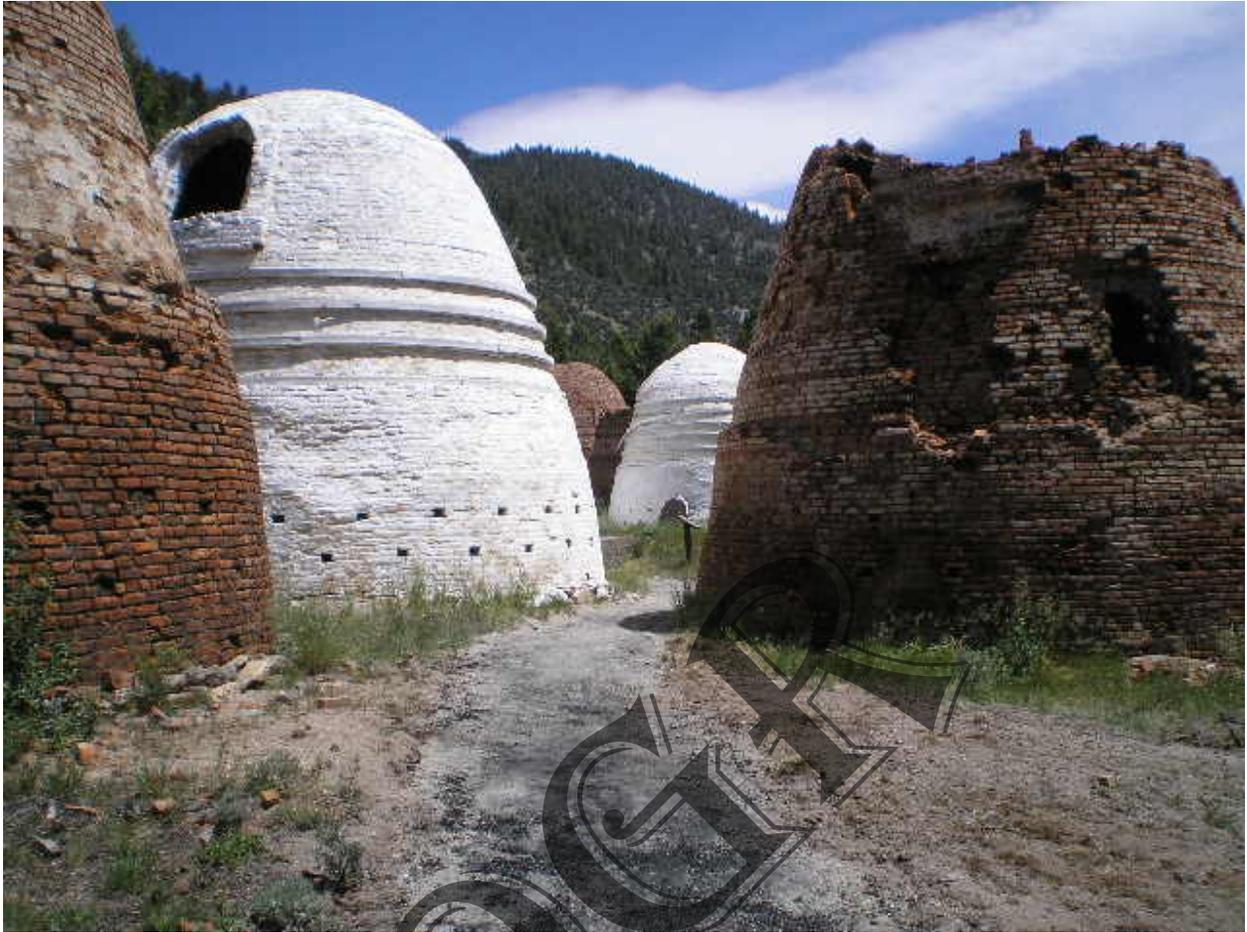
Two of the charcoal kilns at Canyon Creek wear a fresh white coat as a result of recent rehabilitation efforts.

Today, remains at all three locations still stand as a reminder of the 7.5 million bushels of fuel produced for consumption at the Glendale smelter. Recent restoration projects at the largest operation on Canyon Creek, has rekindled life for some of the aging structures. The late Otto Sassman, of Dillon, was instrumental in convincing the US Forest Service to promote and preserve these historic treasures of Beaverhead County's mining past. The remains of the kilns in Sucker Gulch and the kilns on Trapper Creek near Greenwood have fallen into disrepair and by virtue of their location, their existence has practically is unknown.
